# The Implications of Post-Fire Physical Features of Cylindrical 18650 Lithium-Ion Battery Cells

**Abstract.** Fire investigators are trained to apply the scientific method to determine the origin and cause of a fire. They look for patterns that indicate the sequence of involvement of available fuel loads, including considering whether a given fuel load contains enough energy to ignite other fuels. It is common knowledge that cylindrical 18650 lithium-ion (Li-ion) battery cells contain significant electrochemical energy and that they have the potential to fail and cause fires, so they are often considered a potential ignition source. The presence of a damaged 18650 cell at a fire scene poses a challenge to fire investigators because regardless of whether the cell is the cause or a victim of the fire, its stored energy can be released energetically, leaving a burn pattern and rapidly involving other fuel loads. It is therefore desirable to identify post-fire physical features on 18650 Li-ion cells that indicate whether they were the cause or a victim of a fire. This work shows that several features have been incorrectly identified in previous investigations. Expulsion of cell conte

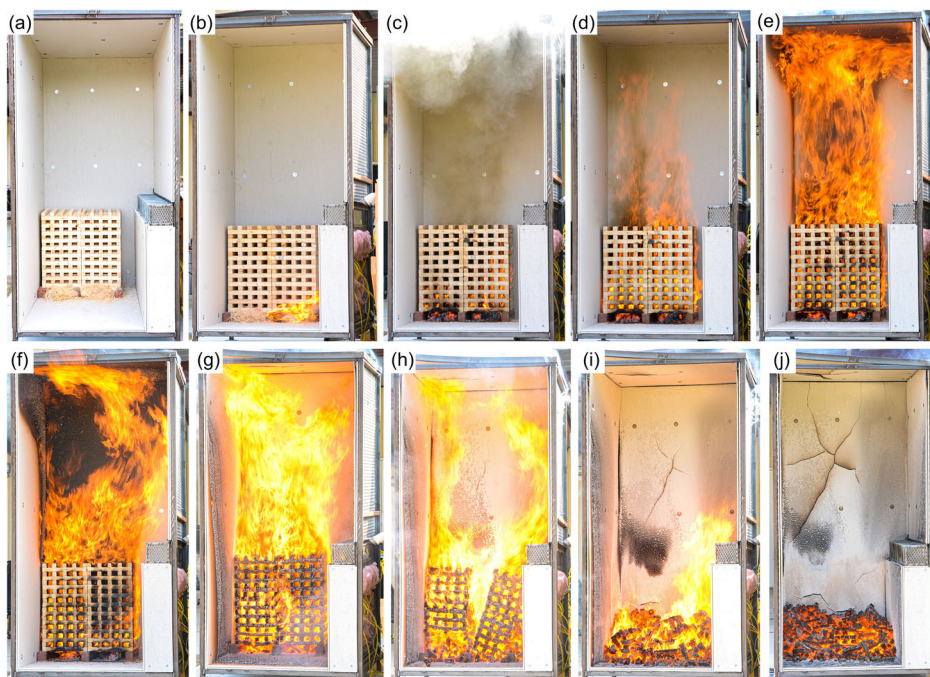
The denatured alcohol was divided into two cans and poured evenly over the top of the wood cribs so they and the underlying excelsior would be wetted. The frontmost portion of the excelsior protruding from under the wood cribs was then ignited with a butane grill lighter. The experiments were performed outdoors near sea level, so adequate oxygen was available from the air and the fire was fuel controlled. The typical fire progression for this experiment is shown in Fig. 4.

**Figure 4. Typical fire progression sequence inside the fire test chamber. 18650 cells are in the cage on the shelf to the right.**

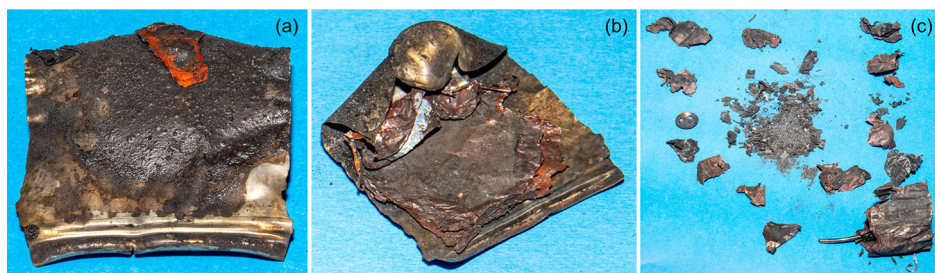
**Figure 14. Photographs of the (a) outside of the enclosure, (b) inside of the enclosure, and (c) expelled contents of cell B100-6. The enclosure split open during testing.**

A hole may be melted through the metal enclosure from the inside of a cell that is the victim of a fire. In the 100% SOC tests for both manufacturers, three out of eight cells had holes melted through their enclosures. While Manufacturer A cells had small holes on the order of one square centimeter located around their crimps, Manufacturer B cells sustained more substantial damage. Cell B100-7 had a large hole that covered half of one side, while B100-3 had a small hole in the crimp (Fig. 13). Cell B100-6 exploded and was reduced to a flattened scrap of metal (Fig. 14). Two Manufacturer B cells with lower SOC's also had holes melted through their enclosures: cell B70-5 had two small holes melted through the corner of the negative terminal and cell B50-8 had a hole melted in and around its positive terminal cap. None of the Manufacturer A cells with less than 100% SOC exhibited melted holes in their enclosures.
